AerDocsis System Software Software Release Notes

lomoM9 20.2.7728

June 18th, 2026

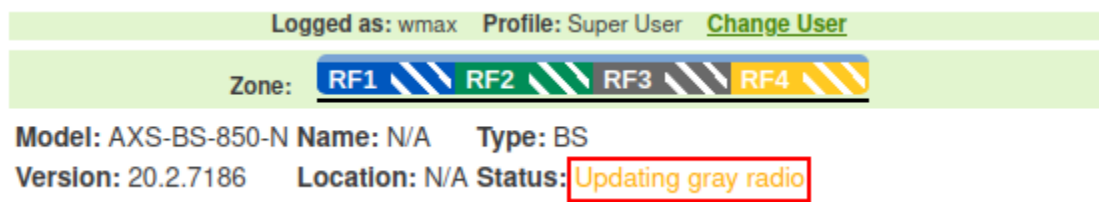
After updating to this release and restarting the device, the system will check if it needs to make updates to the radios' firmware, so it may take longer than usual to be fully operational. If these updates are necessary, the system will notify you on the website with a message as shown in the following image:

It is important that the equipment is not turned off electrically until the update is completed. Otherwise, the firmware may be corrupted and it will be necessary to send the device to the factory for manual updating.
