# **AerDocsis System Software Software Release Notes**

**lomoM4 20.2.7444**

December 19, 2024

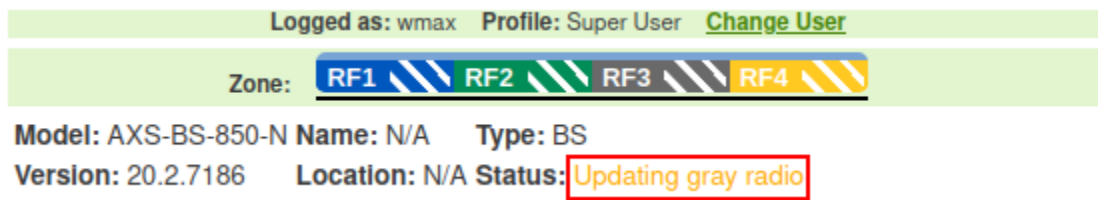
After updating to this release and restarting the device, the system will check if it needs to make updates to the radios' firmware, so it may take longer than usual to be fully operational. If these updates are necessary, the system will notify you on the website with a message as shown in the following image:

It is important that the equipment is not turned off electrically until the update is completed. Otherwise, the firmware may be corrupted and it will be necessary to send the device to the factory for manual updating.
